QA-403
Ashley Building
Centreville
Private

INVENTORY FORM FOR STATE HISTORIC SITES SURVEY

Ashley Building

105-107 S. Commerce St.

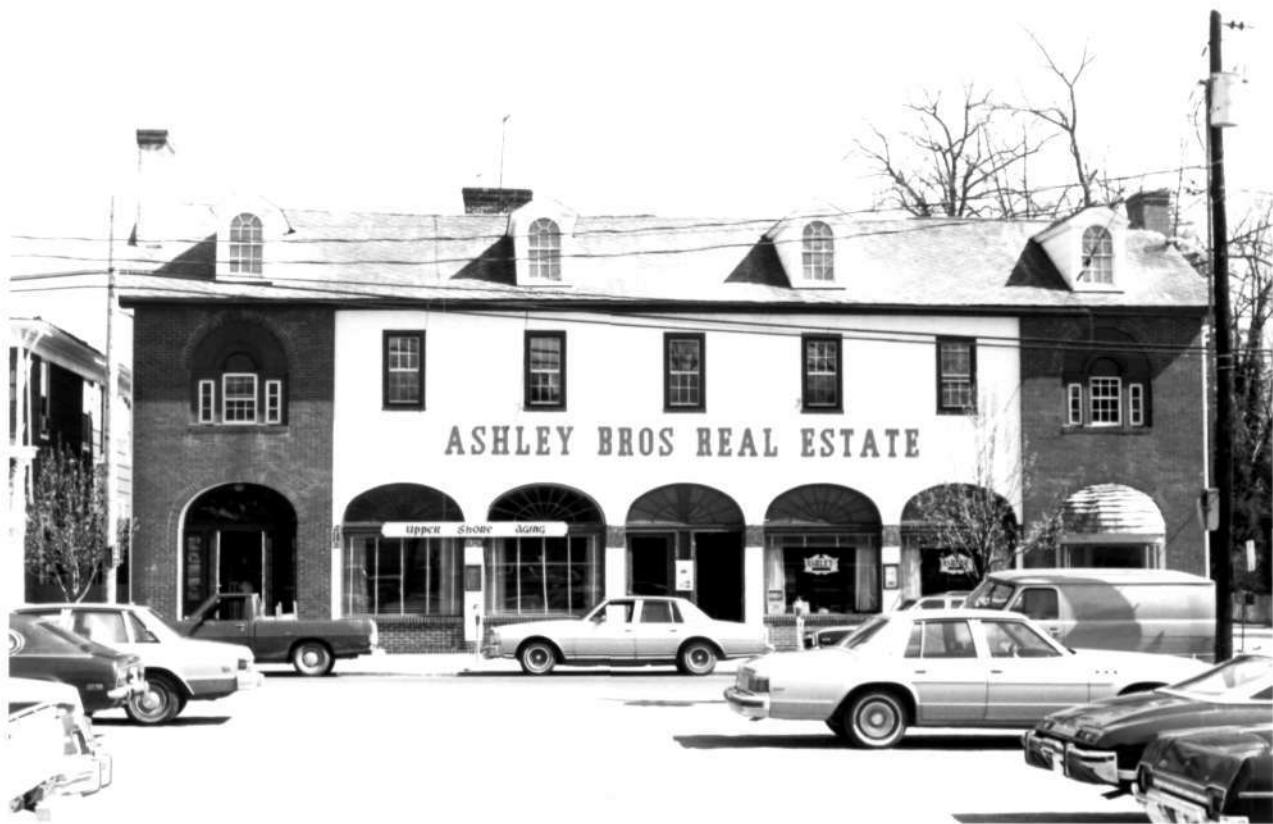
QA-403

The front facade faces west on Commerce Street. When it was remodeled circa 1920, the north bay was faced with new brick, a new bay was added on the south end with matching brickwork, and the five bays between were covered with stucco. Seven large arched openings pierce the first story, and five 6/6 windows on the second story are flanked by triple Venetian windows set in arched recesses. Paired doors in the center bay on the first floor now open into two adjacent offices, flanked by two large shop windows on each side with arched fanlights. The arched opening at the south end was left open as a drive-through to the rear until recently,

Ashley Building
South Commerce Street
Centreville, Maryland
Orlando Ridout V 1981
Front facade from West

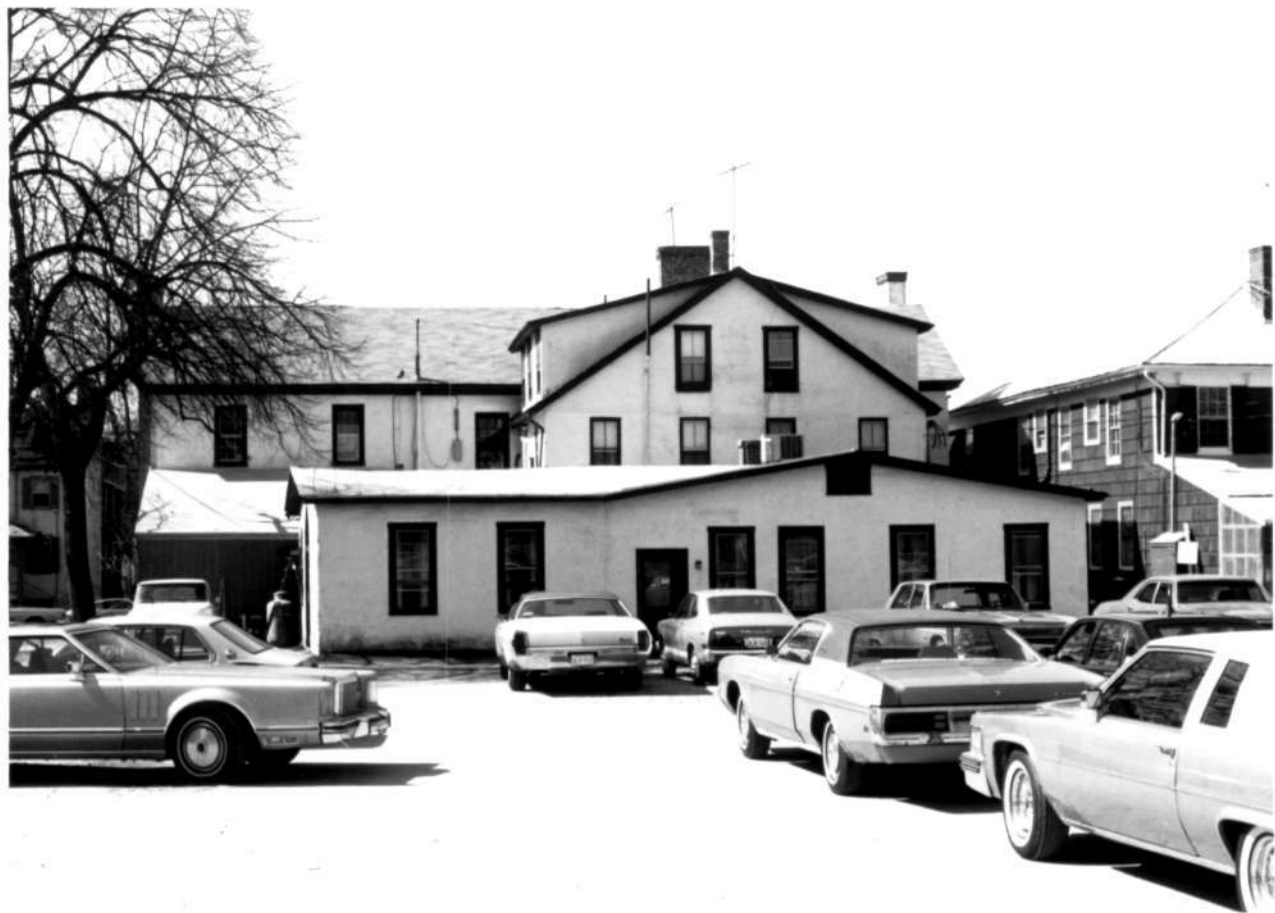
The rear facade has also been heavily altered, and is partially covered by the rear wing. The brick walls remain exposed (but painted) on the north bay, the remainder of the exposed wall has been stuccoed and heavily altered. The exposed brickwork is laid in random common bond.

QA-403 Ashley Building
 South Commerce Street
 Centreville, Maryland
 Orlando Ridout V 1981
 Rear facade from East
